OPTICAL INSPECTION OF SRF CAVITIES AT DESY

S. Aderhold#, Deutsches Elektronen-Synchrotron DESY, 22603 Hamburg, Germany

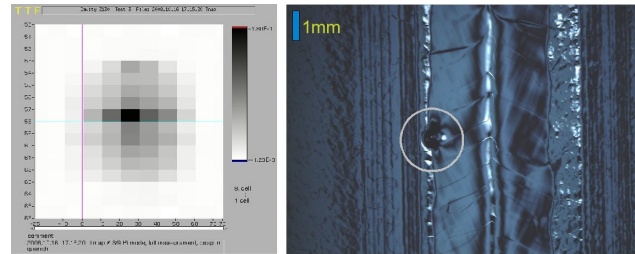
Figure 1: Z130: Hotspot found by T-map during RF-test (left) and defect in optical inspection picture of respective area on inner surface.

In the first vertical RF-test, Z130 was limited by quench at 17.3 MV/m and was therefore cut out of the He-vessel for further investigation. The second test after an additional HPR was carried out with T-map in all nine modes. The π -mode was limited at 16.6 MV/m with quench. The heating spot for the 3/9- and 1/9- π -mode was found on the equator of cell 5 (see left part of figure 1).

Optical inspection was carried out after the second vertical RF-test. A circular pit of about 700 μm was detected at the heating location in cell 5 (right part of figure 1) on the edge of the welding seam.

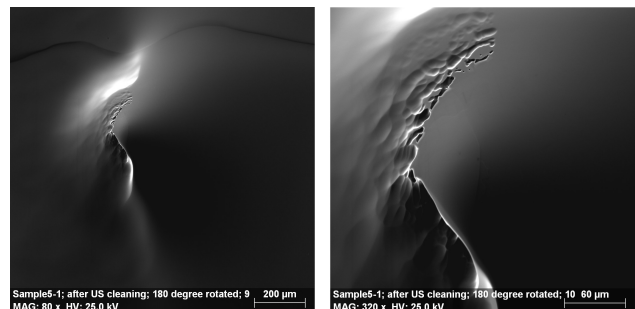
This defect has been subject to detailed analysis by now. Samples have been cut from Z130 for surface analysis, one of them the above described defect [2]. The profile of the pit shows a difference in height between the highest and the lowest point of more than 150 μm . No foreign material inclusion was detected by EDX measurement.

Cutting the sample with the defect from the cavity also allowed taking SEM-pictures with high magnification, as shown in figure 2. At the edge of the defect with its rather large diameter of 700 μm small, sharp structures of the order of less than 10 μm are visible.

Figure 2: SEM-pictures of the defect in Z130: 80x magnification (left) and 320x magnification (right)

The analysis of the sample with the defect cut from Z130 indicates that the cause for the quench lies in the geometrical nature of the defect.

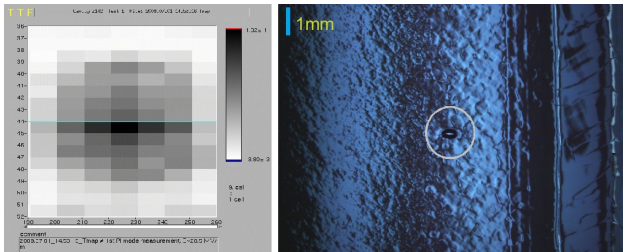
Figure 3: Quench location found by T-map (left) and optical inspection picture of respective area (right) in Z142

In the π -mode Z142 quenched at 20.6 MV/m without measured field emission and heating was observed near the equator of cell 6. Optical inspection of the respective area after the test revealed a defect in the heat affected zone next to the equator welding seam (right part of figure 3). The defect is a pit of elliptical shape with a semi-minor axis of about 300 μm and a semi-major axis of about 500 μm .

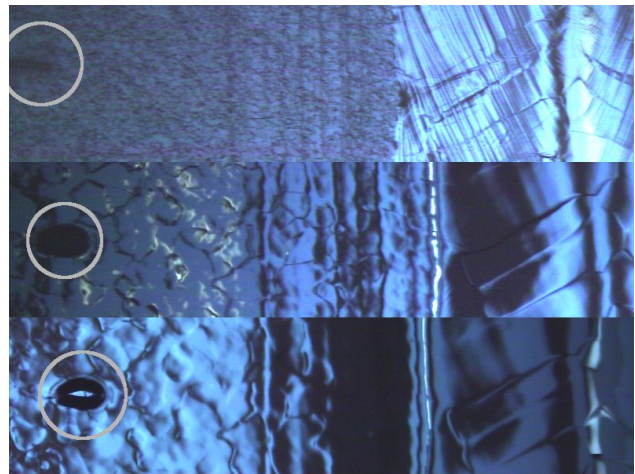
Figure 4: Defect evolution in Z142: Before surface removal (upper part), after main-EP (middle), after final EP and RF-test (lower part)

The upper part of figure 4 shows the surface of Z142 before surface removal directly after the manufacturing. Some millimeters to left of the equator welding seam, one can see a darker spot at the location where the defect is visible later. The middle picture of figure 4 was taken after the bulk surface removal of 108 μm by electro-polishing. Instead of the darker spot an elliptical pit with a semi-minor axis of about 300 μm and a semi-major axis of about 500 μm is clearly visible. The lower picture is the same as in the right part of figure 3, taken after the final EP of 48 μm and the RF-test. The pit has not changed significantly in shape or dimensions with respect to the step before final EP.

In Z142 a defect could be traced through all surface preparation steps from the state “as received” until the RF-test with T-map and confirmation of the defect to be the hotspot.
